BEATRIX POWER FAILURE IN FEBRUARY 2018

Case study

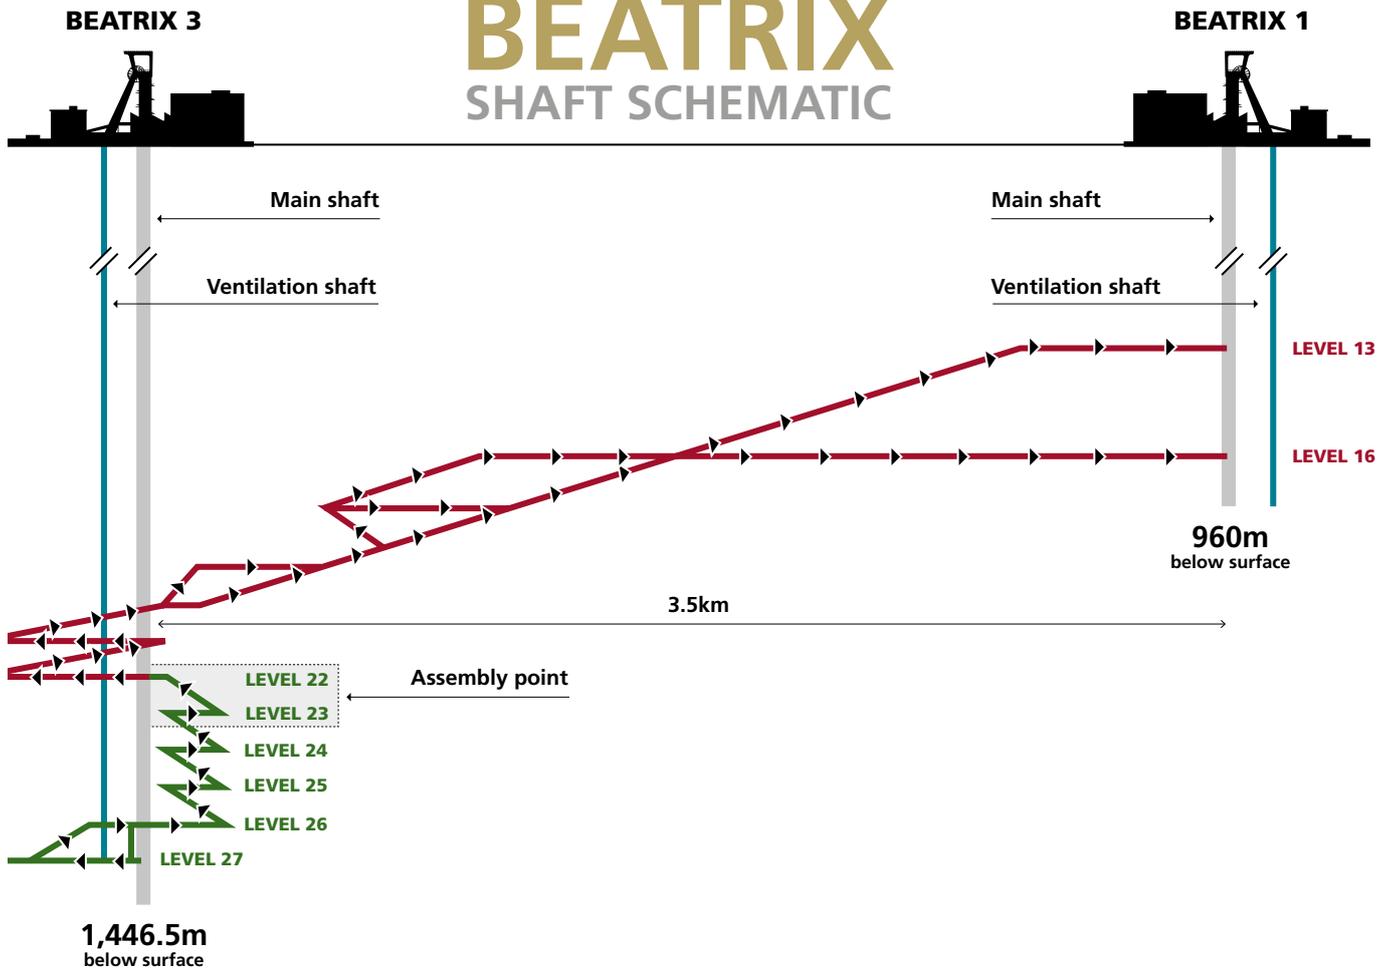
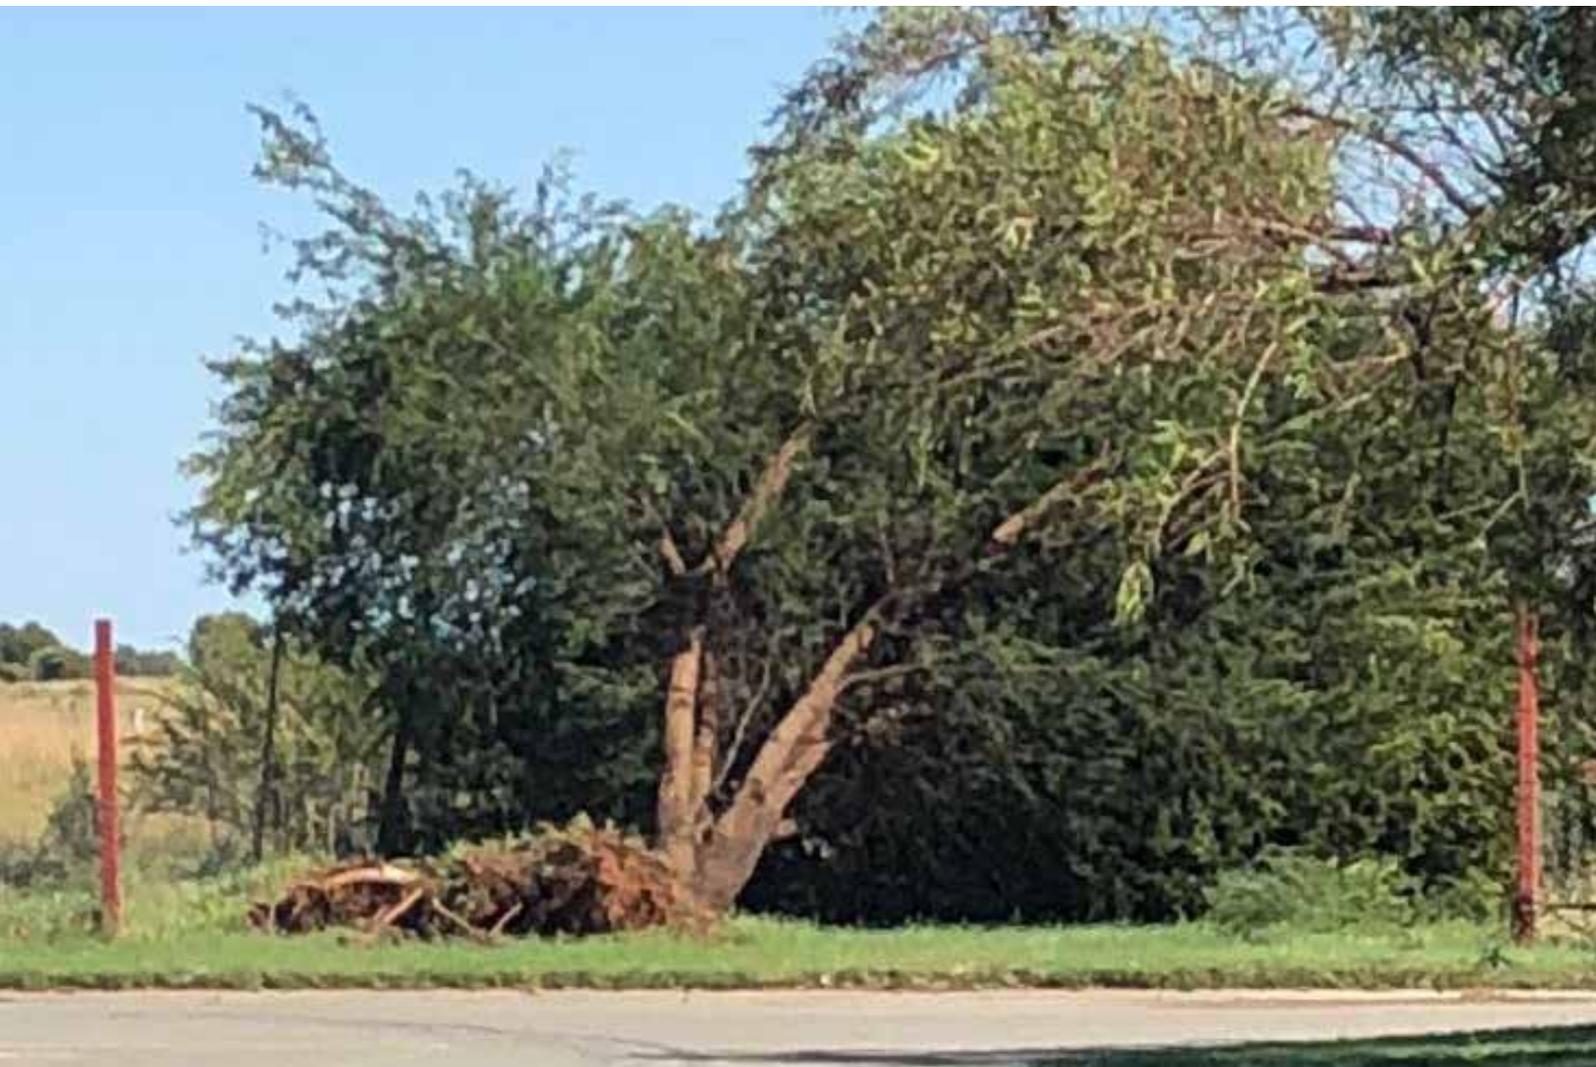
BEATRIX SHAFT SCHEMATIC

At Beatrix 3 shaft, the surge of power as the main supply lines short circuited down to earth, affected the generator and the software in the winder (a highly technical piece of equipment) and the 955 employees who had assembled at the shaft's waiting area could not be immediately brought to surface. Due to the surge-related damage, the generator was unable to reboot the winder software and despite bringing additional generator capacity from Harmony mines in the vicinity and from our Kloof mine, the software issues persisted, delaying the extraction of employees from underground.

All employees could have been evacuated at any time through the secondary escape way (in this instance, Beatrix 1 shaft where the generator was functioning and able to hoist employees). However, this option would have required employees having to walk approximately 3.5km underground while fatigued. While we deployed a large number of mine rescue personnel along the escape way route to provide assistance, in the interests of safety, it was decided by management that employees should remain in a safe and well ventilated area at Beatrix 3 shaft. In this location, we were able to communicate with our employees and provide food, water and medical assistance if required, while we attempted to restore power. In all, 1.2 tonnes of food and water was supplied to employees while they were underground. Waiting for the power to be restored was a considered decision, which proved to be the right one, and at no time were employees at risk.
